# **Results of Auger Analysis** **of** **ATLAS Pixel Chip Wire-bond Pads**

*K. Einsweiler, LBNL and D. Harris, CEA*

**Analysis performed by Charles Evans & Associates, Sunnyvale, CA**

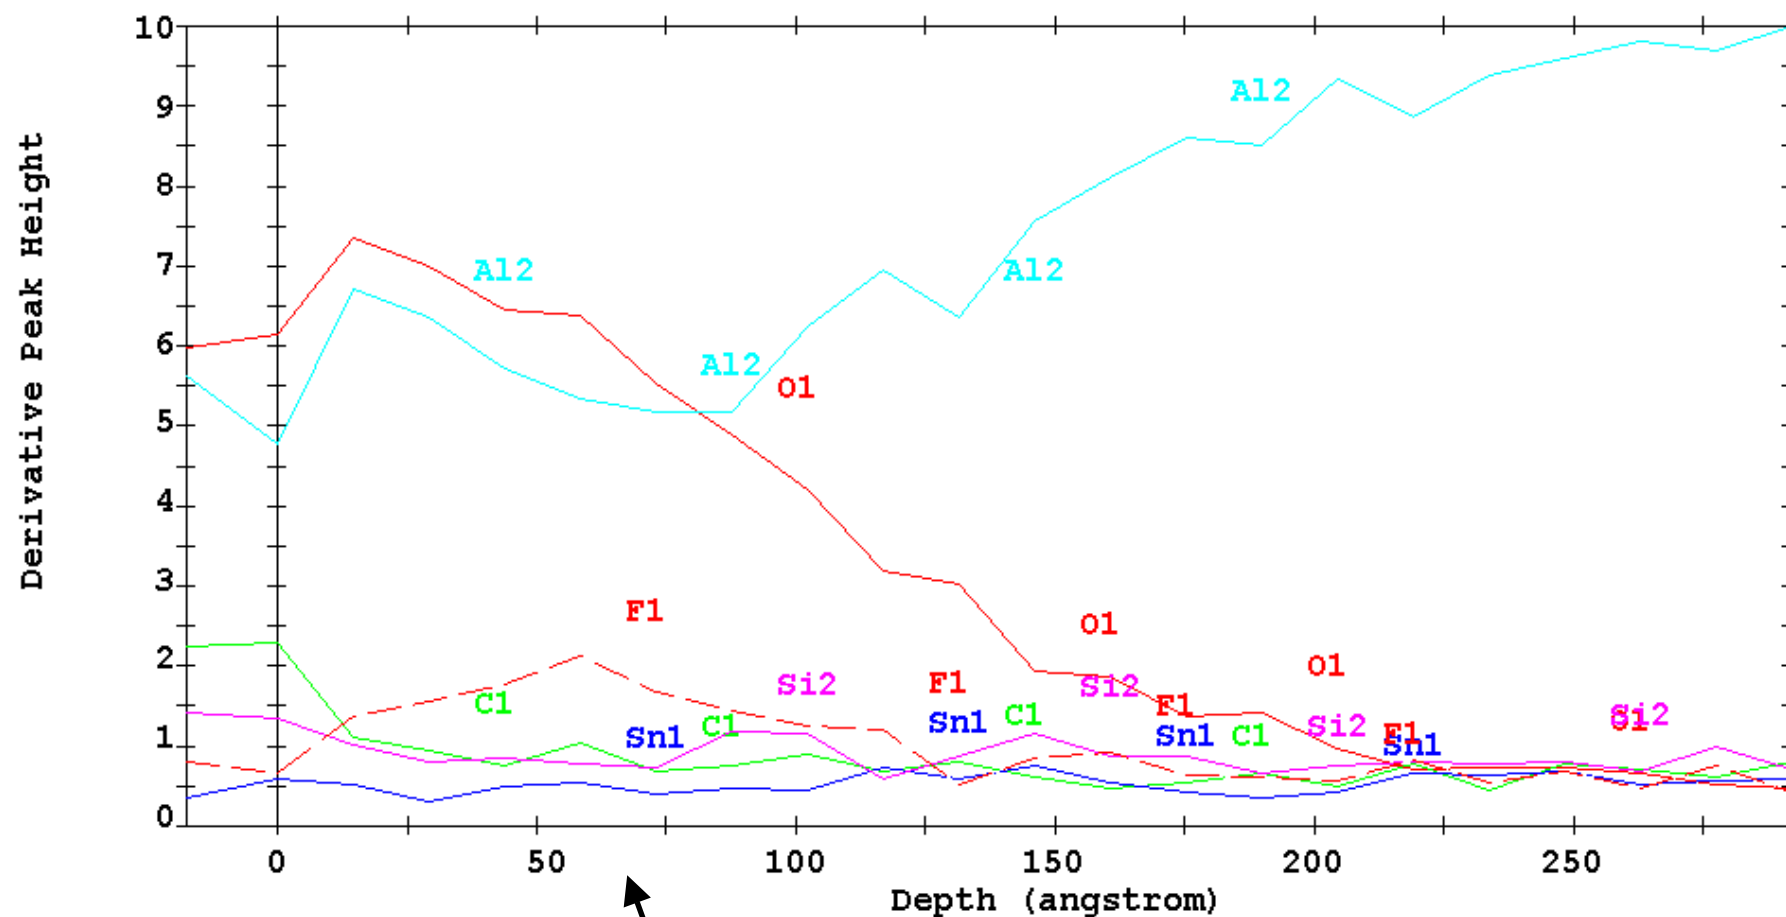
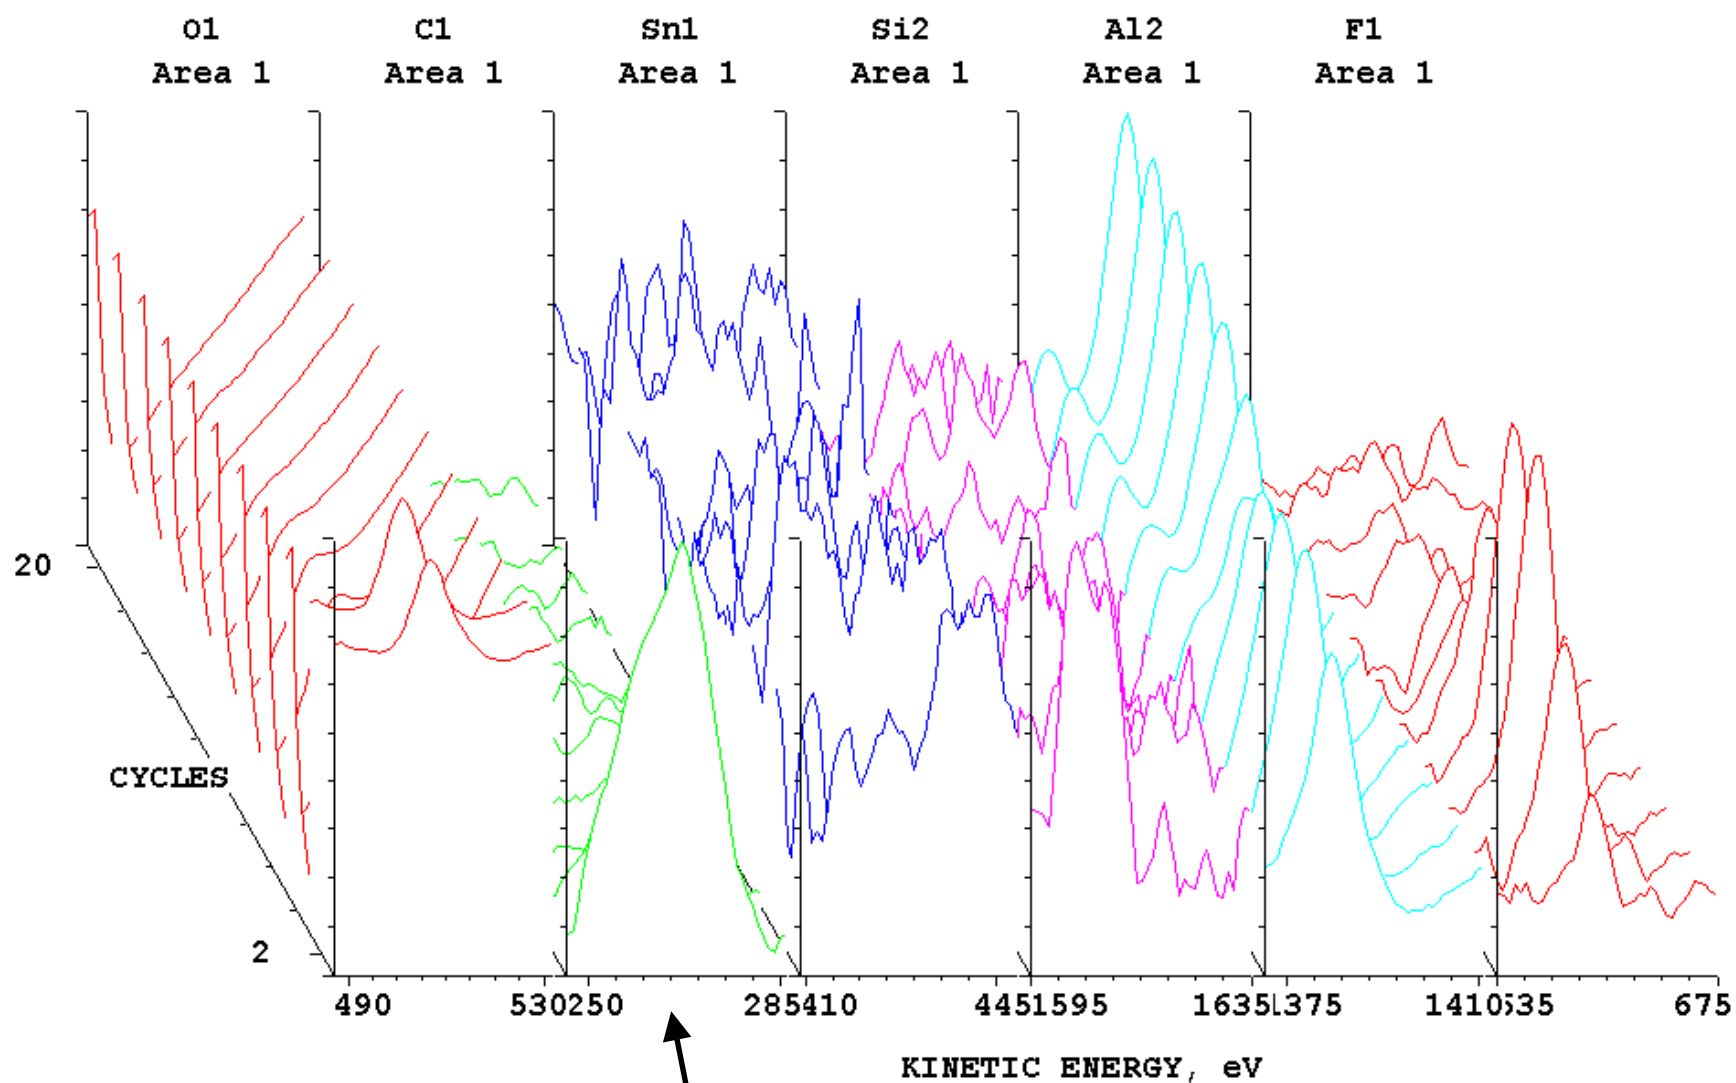
Depth profile of previous peaks, normalized using  
 SiO<sub>2</sub> sputter rate, raw data (not corrected for  
 sensitivity).

- Depth profile shows presence of Al oxide layer of about 100Å thickness. This is seen as an O peak which disappears after about 100Å. Also, in the Al depth profile, the character of the peak is seen to change from “non-elemental” to “elemental” (displacement of peak and secondary shoulder appears).
- A small amount of F contamination is seen in the oxide layer. This is a typical residue of the plasma etch step used to make the openings in the passivation layer for the bond-pads (normally uses CF<sub>4</sub> or similar).
- Once the analysis passes through this Al oxide layer, there is pure elemental Al and nothing else.
- No other material is seen. This is a very normal bond-pad. Wire-bonding is usually successful up to Al oxide thicknesses of more than 200Å, so this would not present any problems.

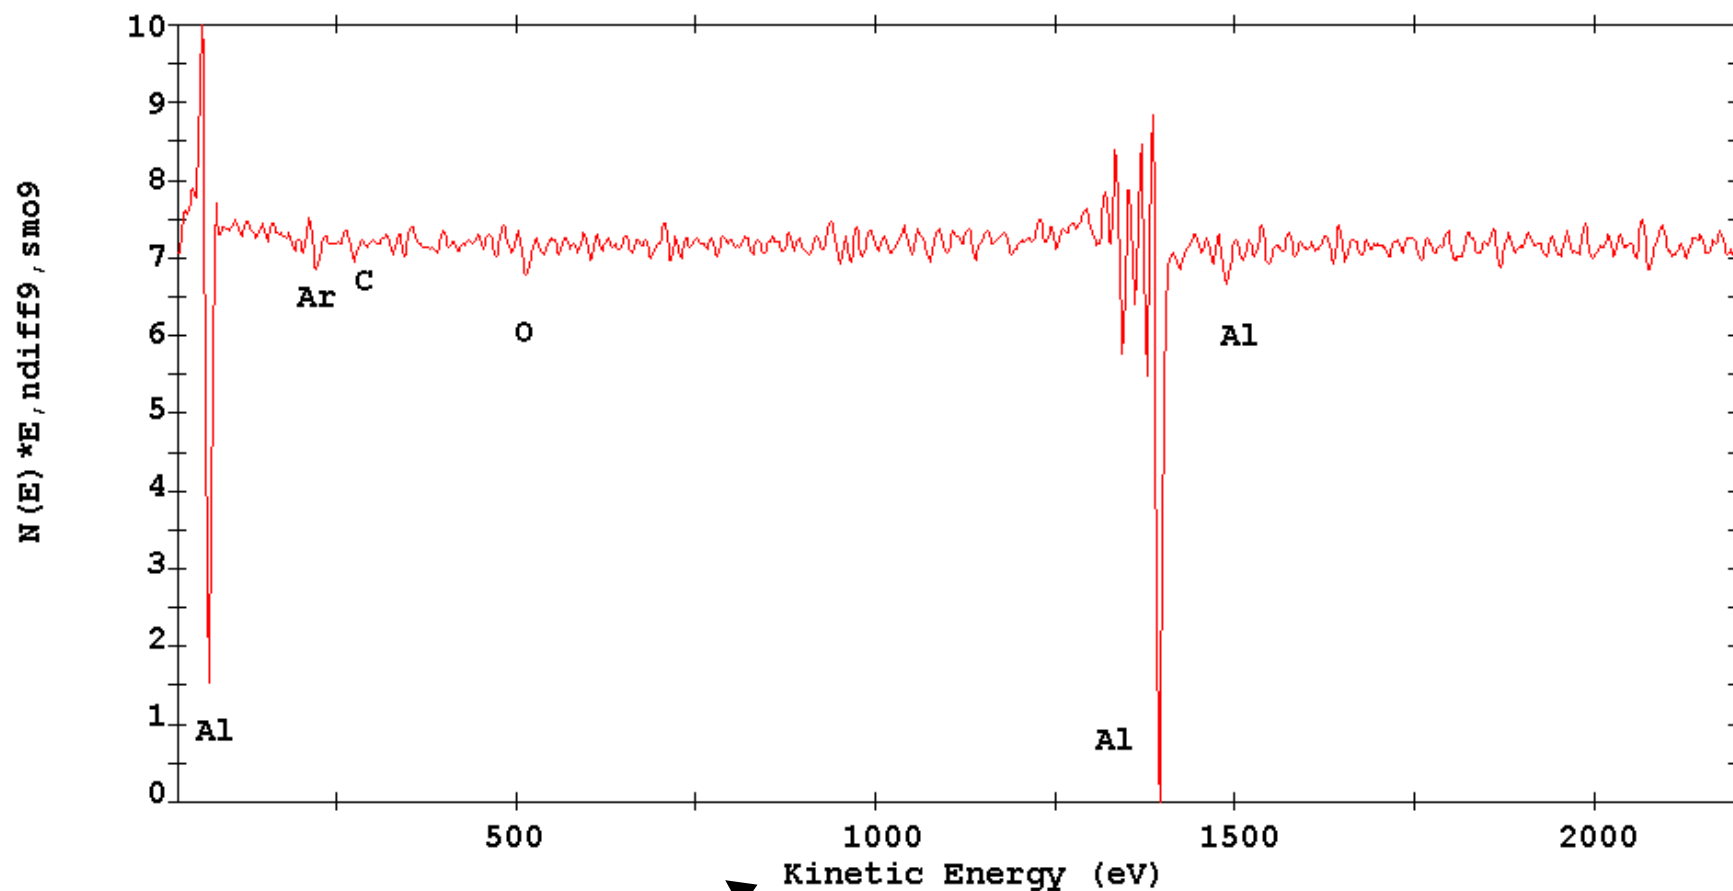
**Final full survey, showing  
only pure Al pad.**

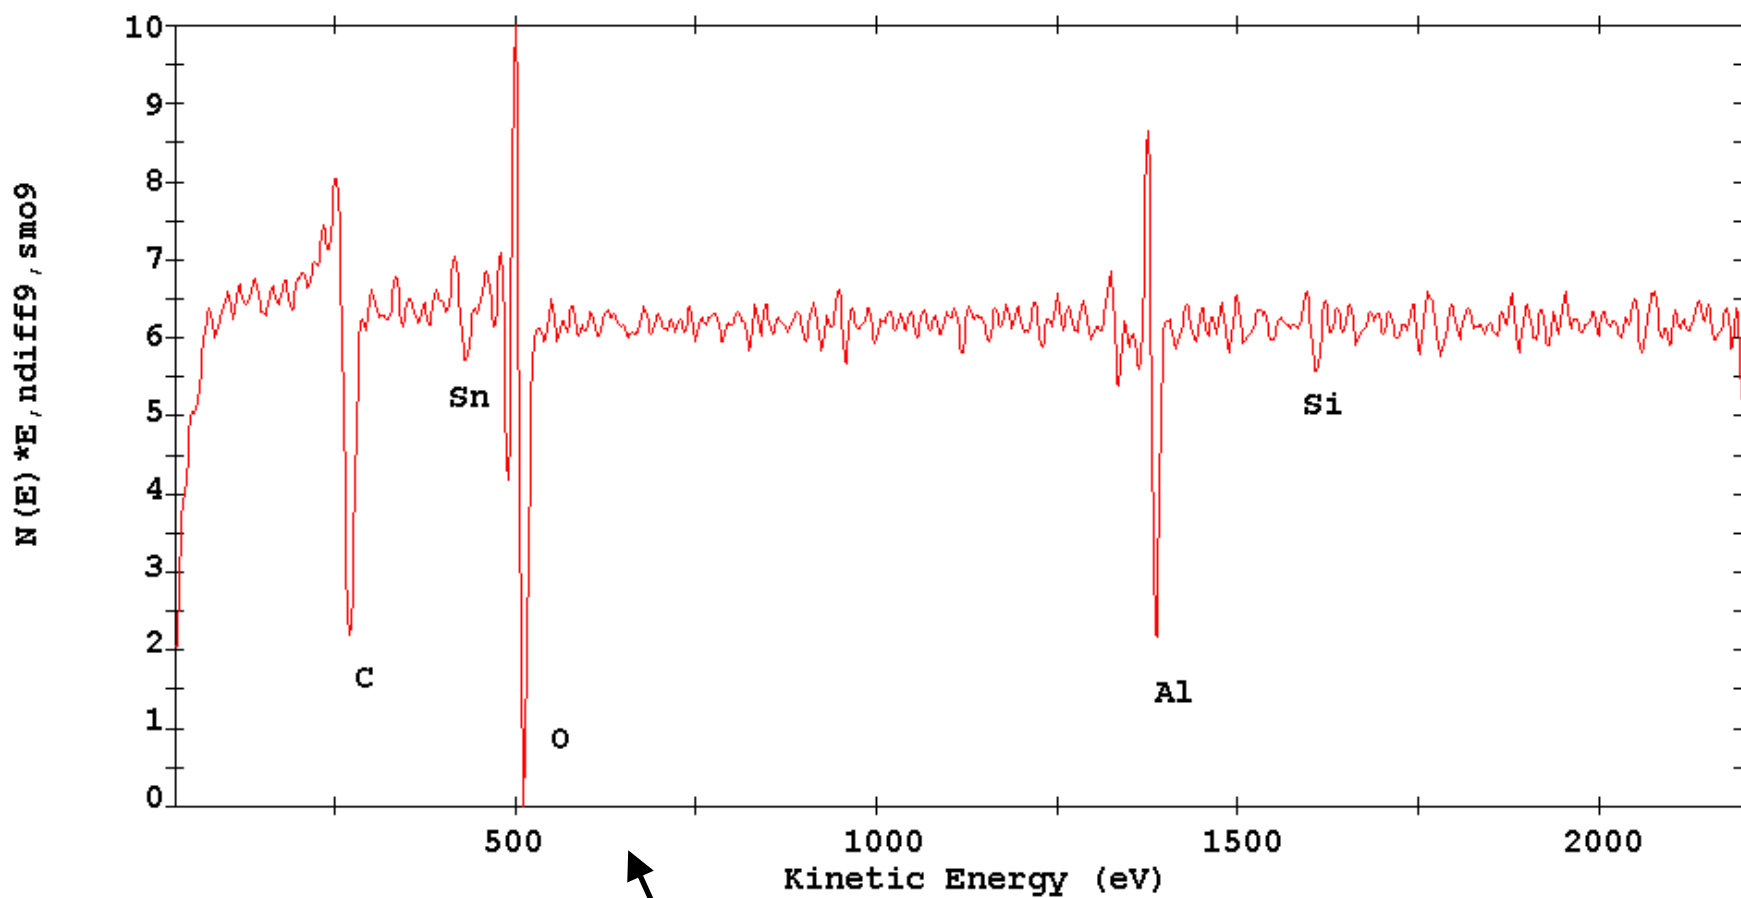
**Initial full survey. Note presence of some Sn and significant C (Auger not sensitive to H).**

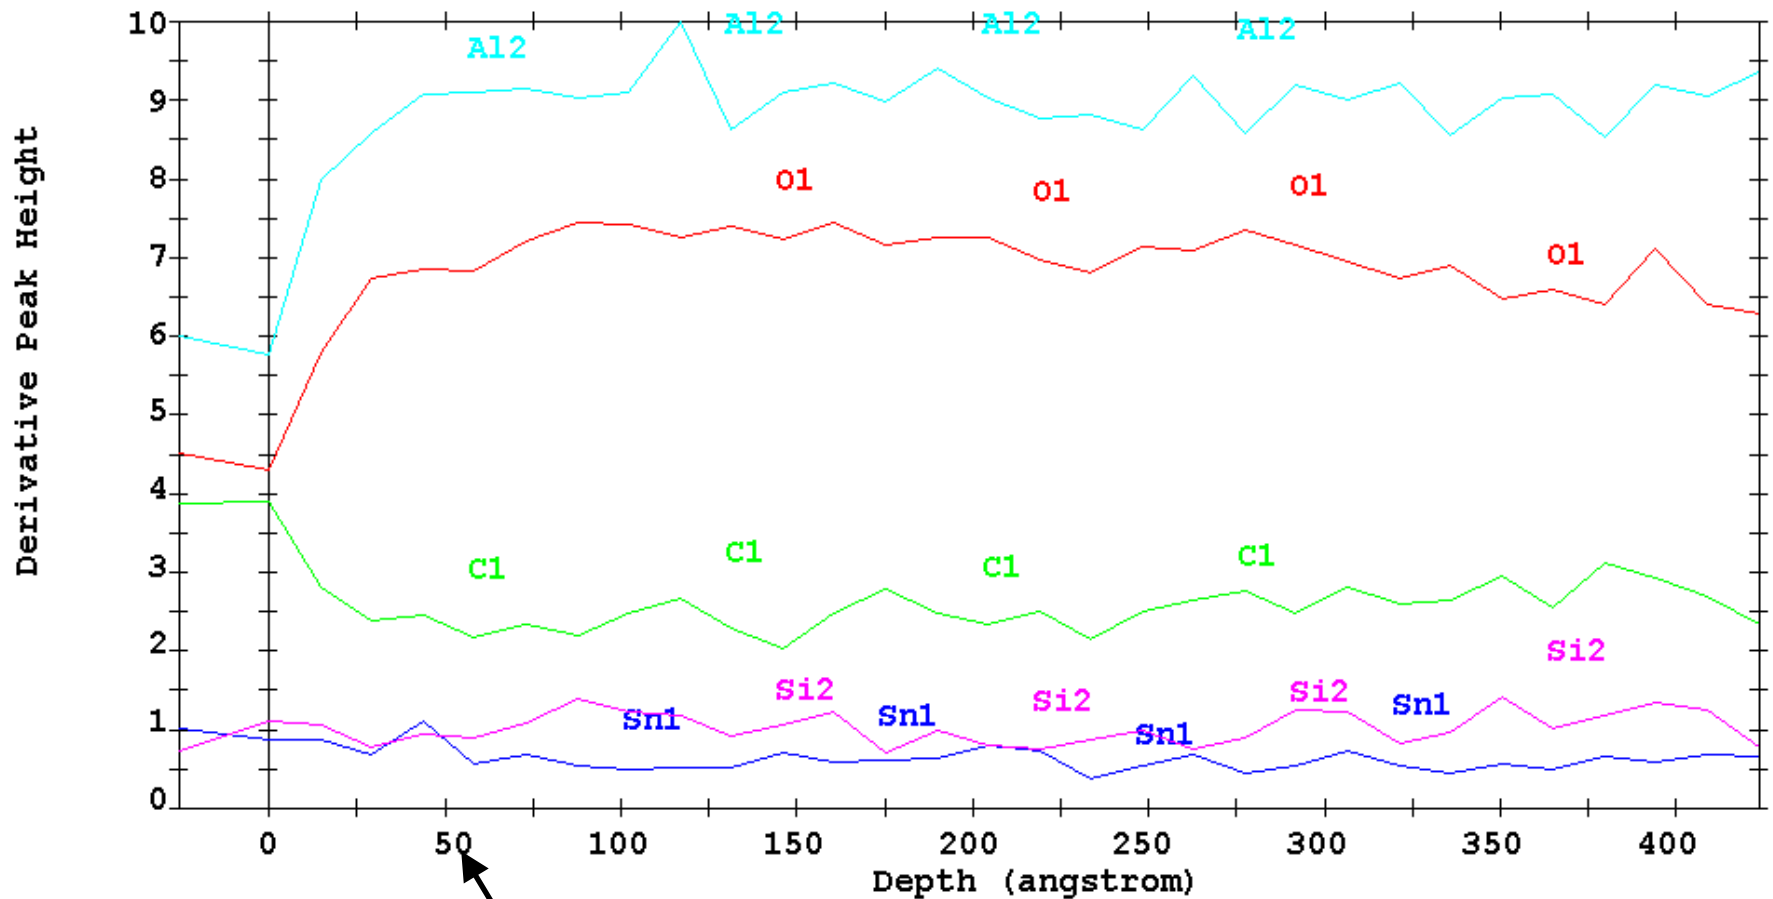
**Depth profile, showing very little change down to 400A.  
Normally, would have reached Al pad at this depth.**

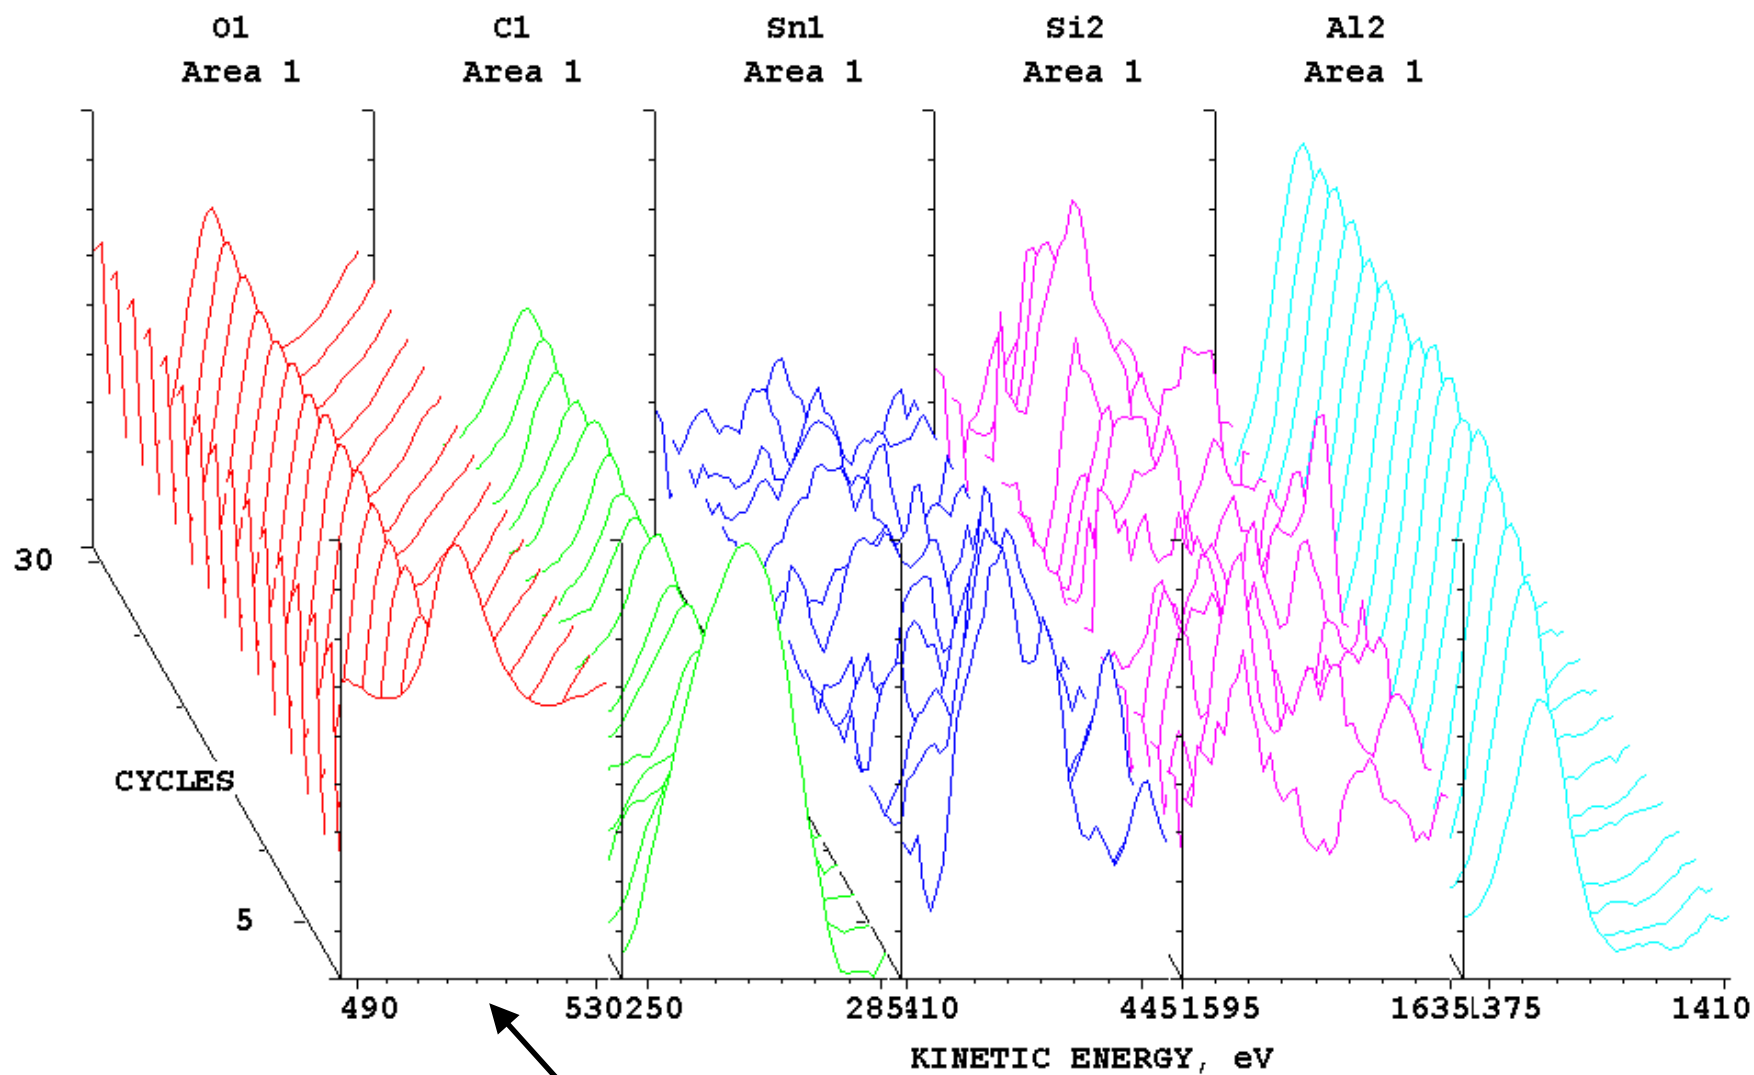
**Individual spectra show Sn quickly disappears,  
leaving Al (non-elemental), O and C.**

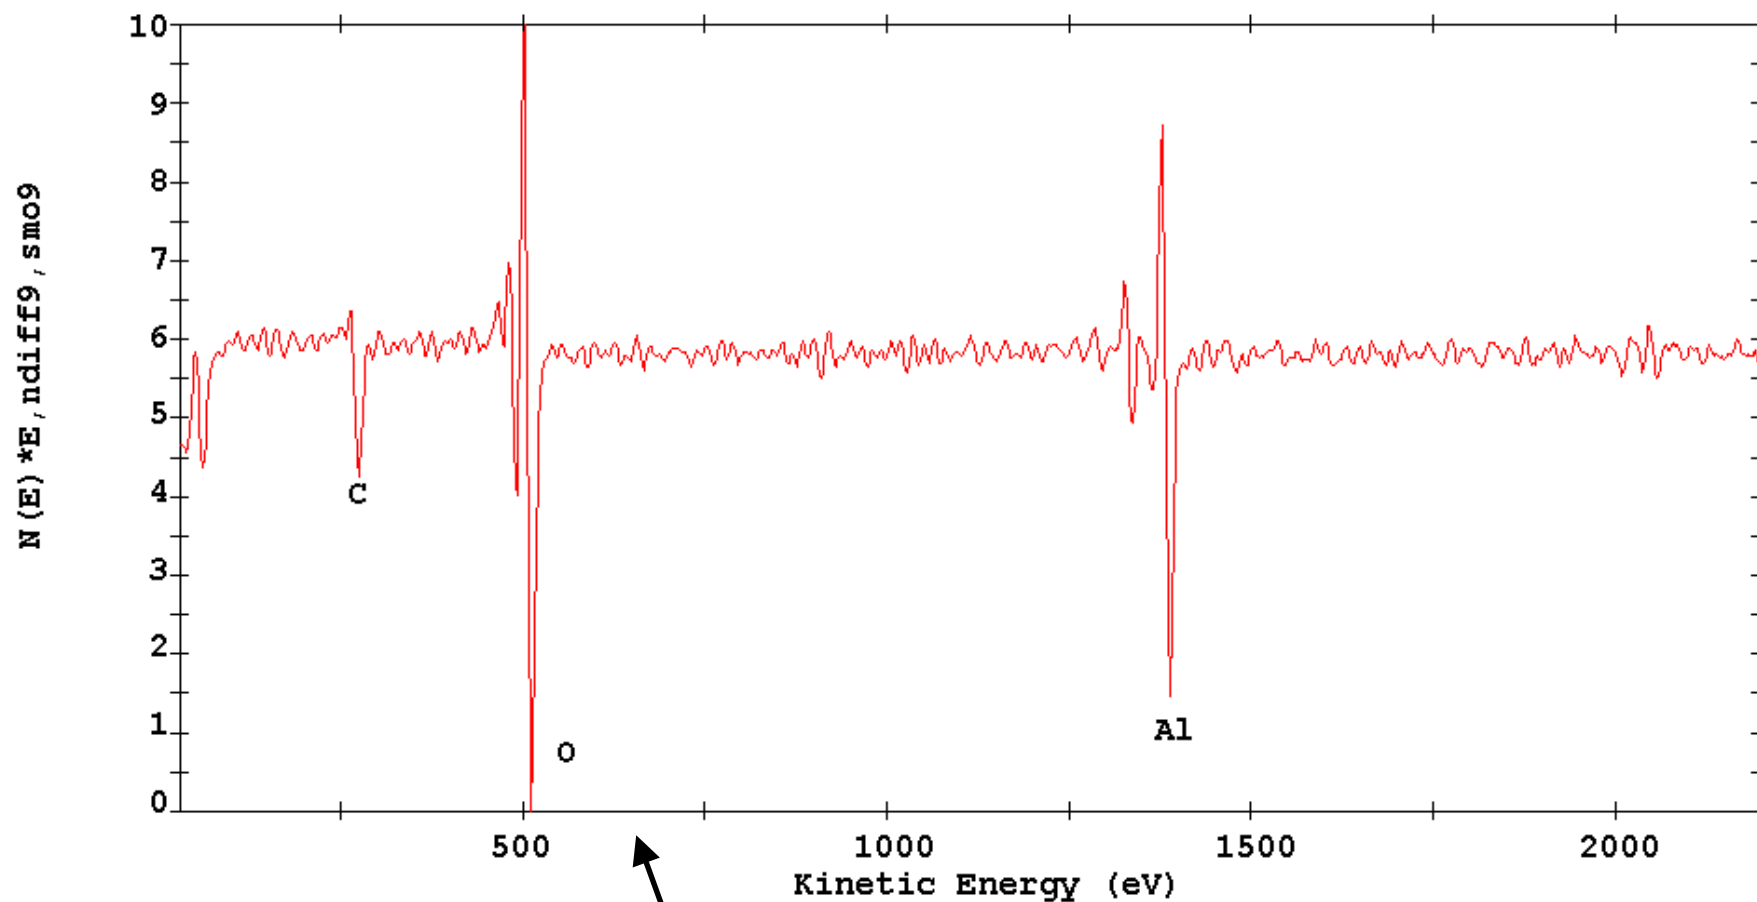
**Final full survey shows only Al, C, and O.  
The observed Al peak is not elemental Al  
expected from clean pad.**

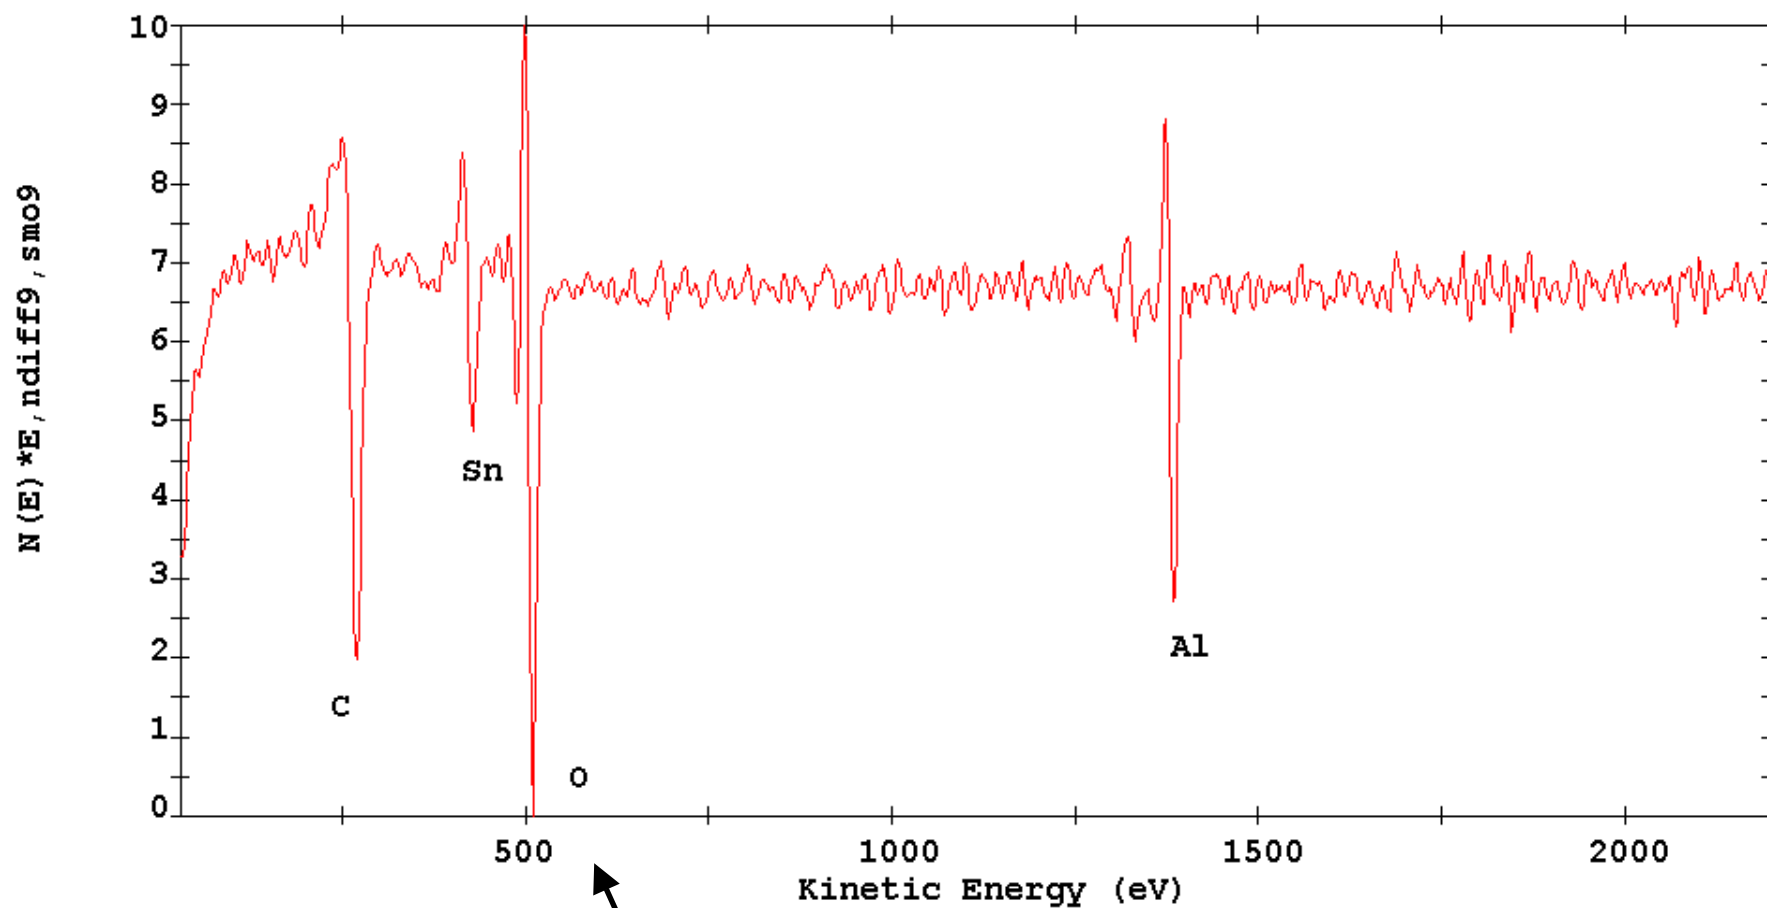
**Initial survey again shows some Sn and lots of C.**

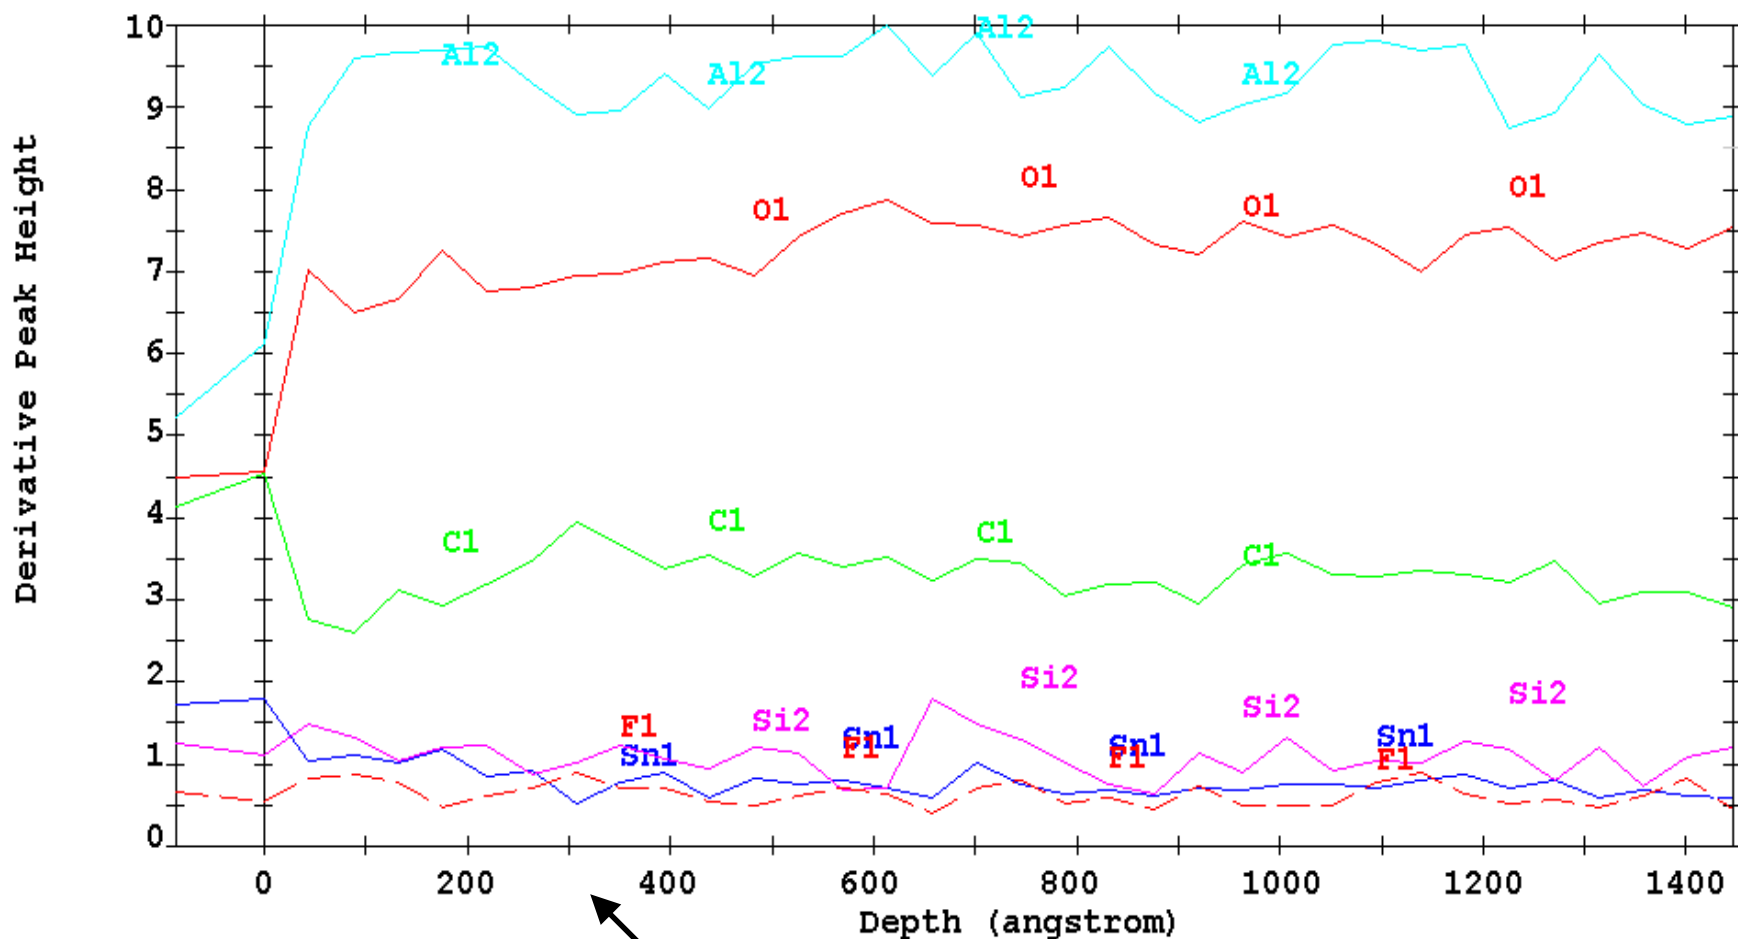
Depth profile done in larger steps, and extended to much greater depth. Still no end to contamination was found.

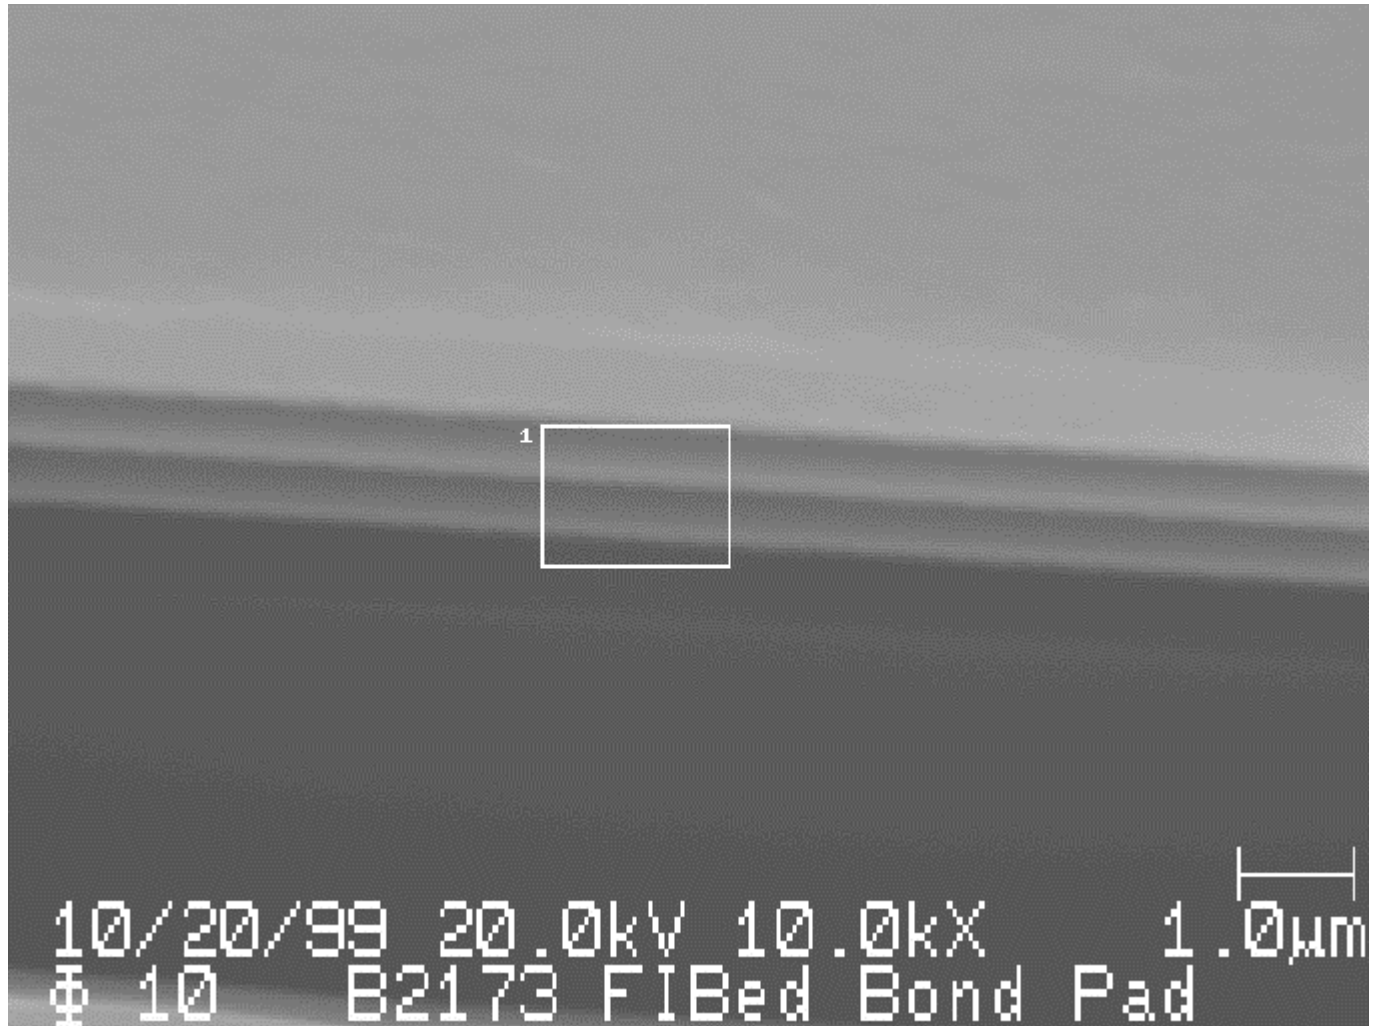
**Clearly see presence of 3 Al layers in pad.**

- Can clearly see three Al layers present in HP bond-pad, W via material and oxide between layers.
- Carbon/Oxide layer is on top of the upper Al layer, and it is quite thick. It is essentially impossible with this analysis to see the “corner” of this layer and hence measure its thickness (there is no distinguishing feature between the body of the layer and the surface of the layer).
- In the end, the line analyses were quite inconclusive.
- As a final step, another area analysis was done, increasing the sputter cycle step size still further, and extending the depth of the scan.

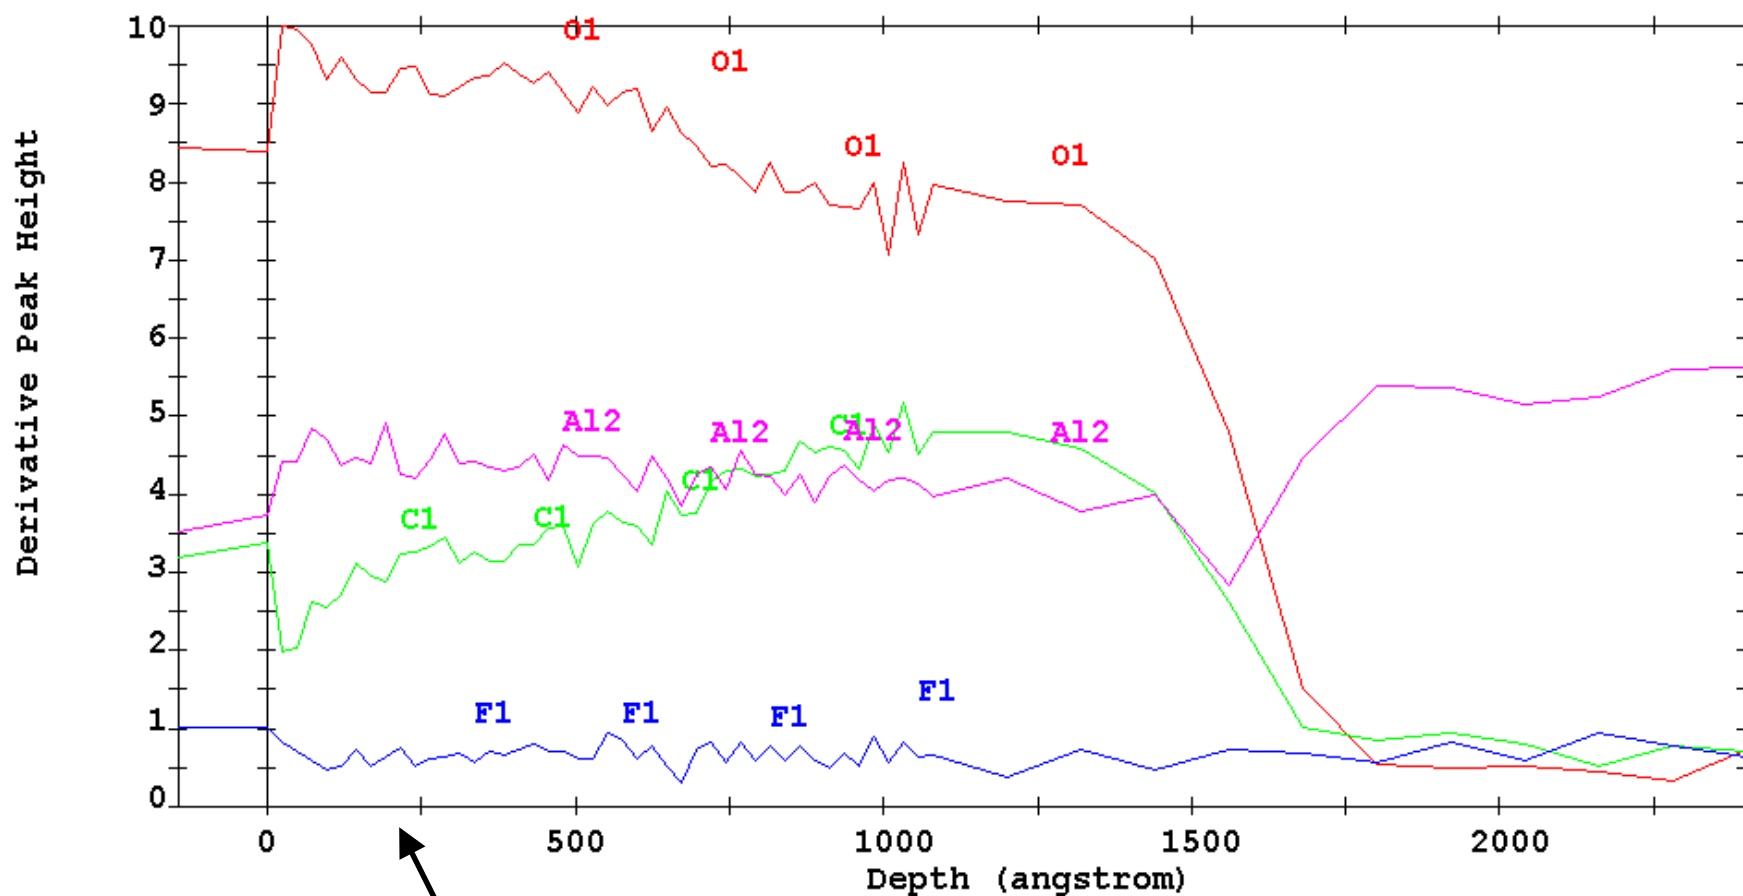
**Depth profile shows the end of the C and O contamination. There is no sign of the native oxide (with tell-tale F signal), but step size was very large.**

- No contamination is seen on the pads prior to bump-deposition.
- Significant organic contamination is present after both the bump-deposition step and the final flip-chip step (there seems to be no obvious difference between the two). The thickness of the contamination layer is difficult to measure because its sputter rate is probably lower than SiO<sub>2</sub>. The expert quoted a range of 600-1500Å, based on his experience with sputter rates.

- The expert was rather astonished that we could bond at all to pads with this level of contamination. Certainly reliability and pull-strength will not be normal under these conditions. Hopefully, after better understanding of the IZM processing steps, modifications to the processing can be made to eliminate this contamination.

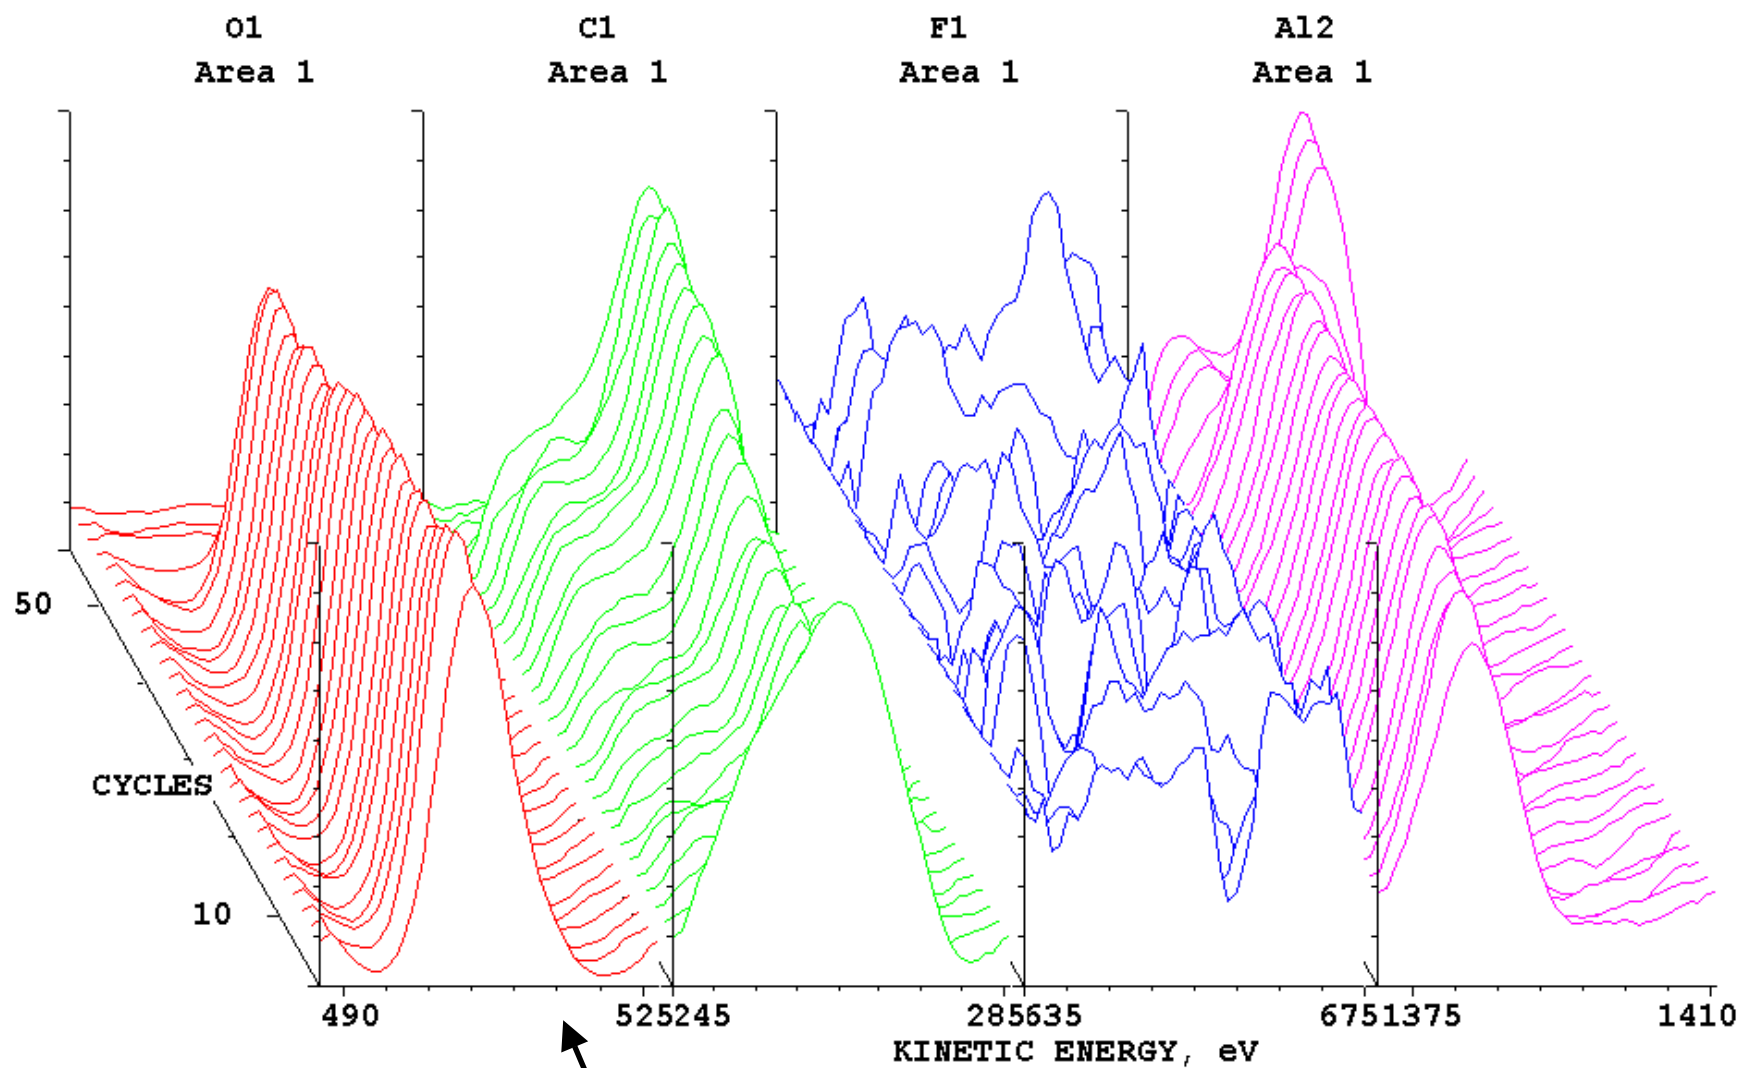
**Spectra show that elemental Al was finally reached.**
